Failure Analysis of a Helical Gear

Abstract

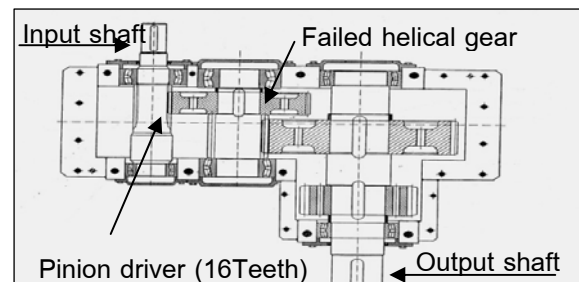
The failed helical gear has 69 teeth, and the face width of 128 mm. The module of the gear is 8 mm, the helix angle 13 degrees and the pressure angle 20 degrees. The reducer gearbox ratio and input shaft revolution are 15.90 and 400 rpm, respectively. The mechanical power is 300 kW and the safety factor is 1.75. Relevant layout of the reducer gearbox is shown in Fig. 1.

Fig. 1 Location of the failed gear

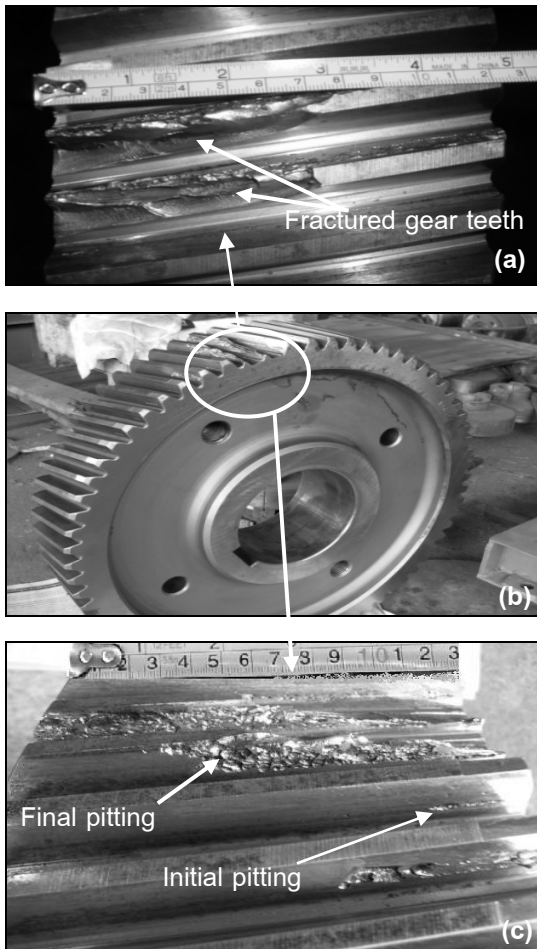
The appearance of the failed helical gear is as shown in Fig. 2. Visual examination of the gear revealed two broken teeth as shown in Fig. 2a. The arrows in Fig. 2c showed the initial pitting and final pitting on the contact side.

Fig. 2 Fracture and pitting occurrence in the failed gear

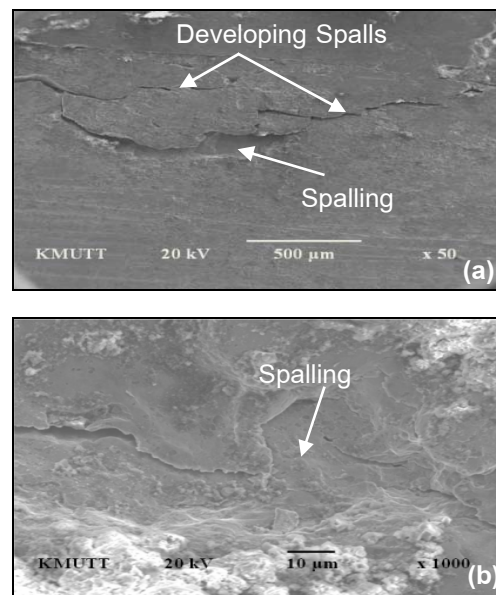
were pitting and spalling areas on the active side of the gear tooth as shown in Fig. 3a, b. The presence of extensive sub-surface spalling at the active surface side of the gear tooth was an indication that during operation the gear tooth was subjected to a contact stress that would have been high enough to initiate fatigue cracks. Beach marks, which are one of the typical characteristics of fatigue fracture, were clearly visible on the fracture surface as shown in Fig. 4. The width of the beach marks are about 44 μm .

Fig. 3 Spalling of gear surface

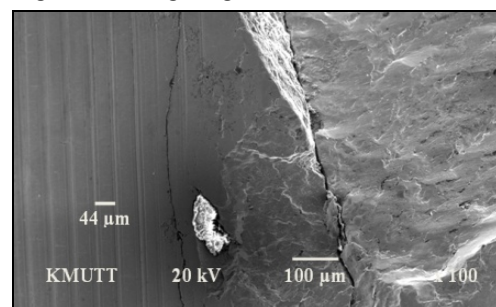
Fig. 4 Beach marks

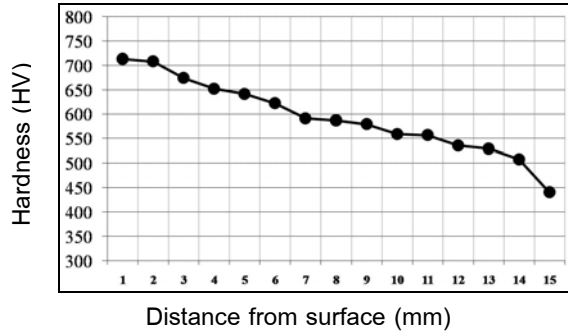
hardness at the case and minimum at the core were found to be 713.2 HV (60.7 HRC) and 440.5 HV (44.5 HRC), respectively. Fig. 5 indicated that the gear had been case hardened by carburization which is normal practice for gear heat treatment.

Fig. 5 Microhardness distribution of the failed gear tooth

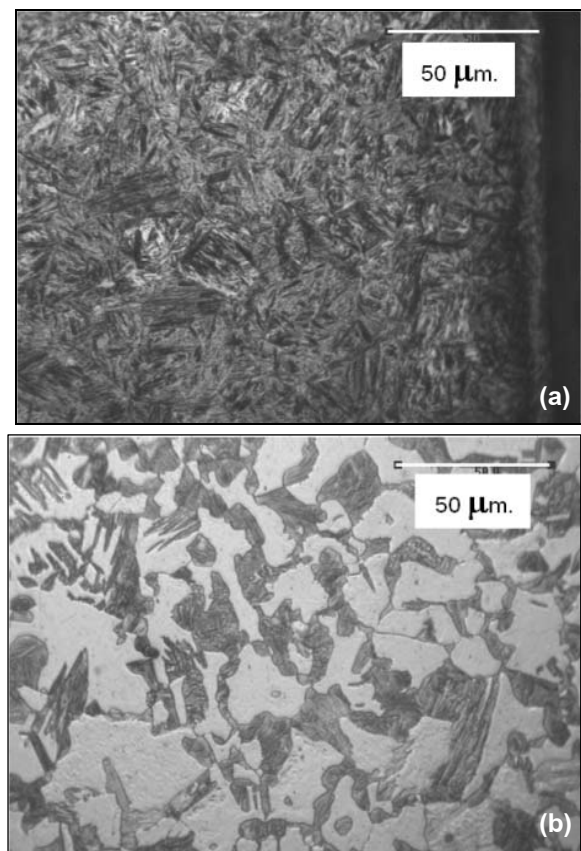
IA32-Image analysis system). The case microstructure is tempered martensite as shown in Fig. 6a. The core is a mixture of ferrite and pearlite as shown in Fig. 6b. The microstructure indicated that the gear heat treatment condition was carburized, quenched, and tempered which is common practice in heat treatment of SCM415 steel. The crack that leads to final fracture is transgranular and is filled with oxides as shown in Fig. 7. No abnormality was found in the microstructure.

Fig. 6 Optical micrographs showing the microstructure of the gear tooth (a) tempered martensite, (b) mixture of pearlite and ferrite

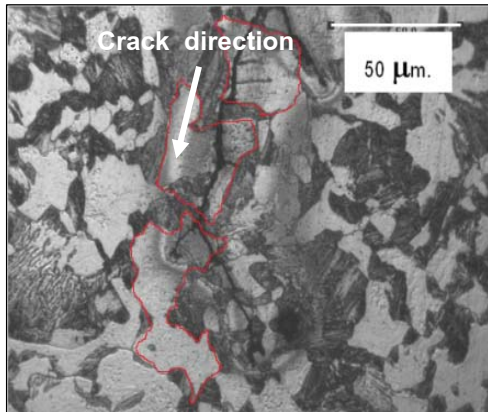
Fig. 7 Transgranular crack
